Preserving Historic Landmarks Meets Slope Stabilization: Spesa Restores Retaining Walls at the Old Synagogue in Hohenlimburg

- Renovation of two dilapidated retaining walls at the Old Synagogue in the Hohenlimburg, Germany, on behalf of the Wirtschaftsbetriebe Hagen
- Demolition, restoration of the historic material, and reconstruction of the walls in accordance with historic preservation guidelines
- Additional slope stabilization using shotcrete and anchors

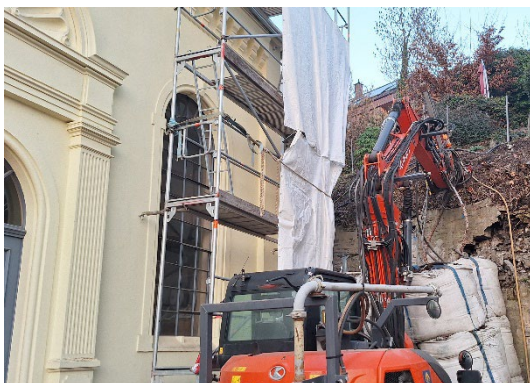
(1) The bulk bags installed as an emergency stabilization measure between the wall and the synagogue are preventing further deterioration.

The combination of confined site conditions, heritage preservation requirements, and the need to leave the bulk bags in place as temporary support elements makes this renovation project a logistical and technical feat requiring precision. The focus is as much on treating the historic surroundings with care as it is on permanently restoring structural stability. Work began in February and is expected to be successfully completed in July 2026. With this restoration, Spesa is making an important contribution to preserving this culturally significant site while creating a safer and visually enhanced environment for visitors.

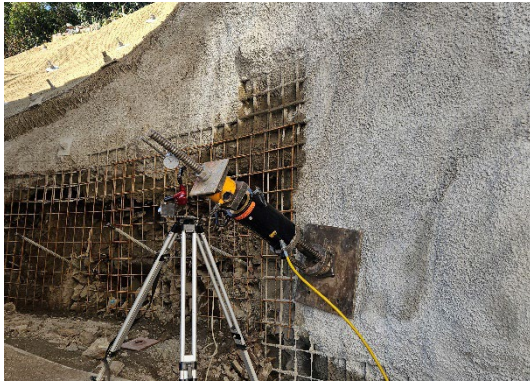
(2) Following the dismantling of the historic masonry, the slope itself is stabilized using a shotcrete shell and anchors.

After demolition, the slope is secured by applying a shotcrete shell using drilling and excavator rigs. On an area of approximately 150 m², 75 tons of shotcrete are applied and additionally secured with 110 anchors. Only after completion of this load-bearing slope stabilization system will reconstruction of the retaining walls begin using the original historic stone material. Existing brickwork discovered on site will not be reused; instead, all sections will be rebuilt exclusively with natural stone. Missing stones will be replaced with comparable, locally sourced natural stone to preserve the historical appearance. The space between the shotcrete shell and the natural stone masonry is then filled layer by layer with single-grain concrete. “This method allows us to precisely control the pressure exerted by the fresh concrete,” says Sebastian Otto. “The new natural stone wall does not serve a load-bearing function for the slope. It supports only its own weight and the pressure of the drainage layer.”

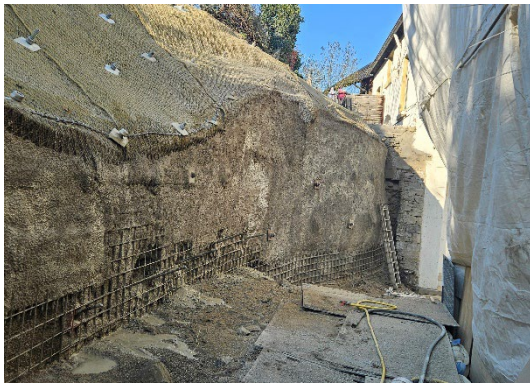
(3) A total of approximately 150 m² will be secured with 75 tons of shotcrete.
